ELIZABETH RIVER BASIN  
ELIZABETH RIVER, UNION COUNTY  
NEW JERSEY

**URSINO DAM**

**NJ 00387**

**PHASE 1 INSPECTION REPORT  
NATIONAL DAM SAFETY PROGRAM**

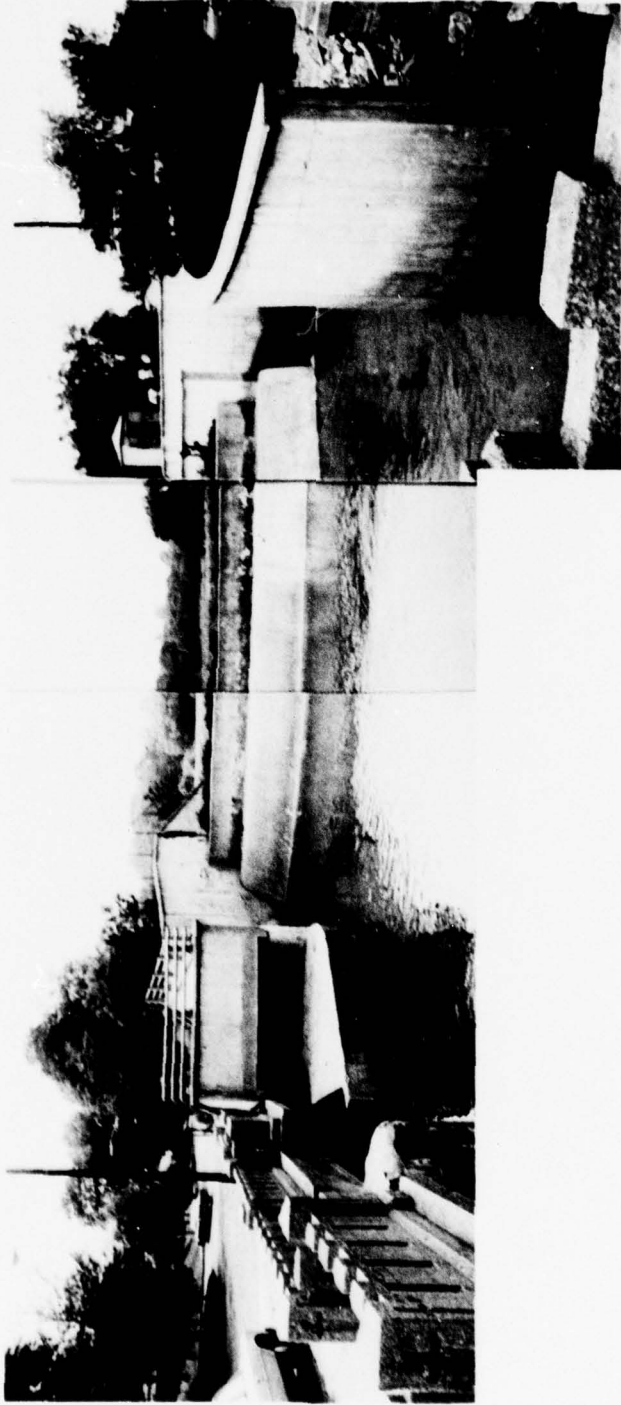
URSINO FLOOD CONTROL PROJECT LOOKING UPSTREAM FROM TROTTERS LAND BRIDGE

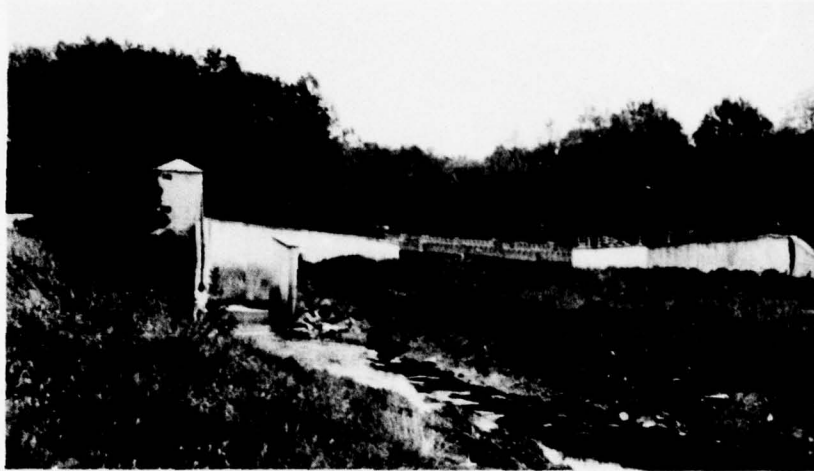
LOOKING DOWNSTREAM AT ELIZABETH RIVER AND URSINO DAM WITH  
CONCRETE CHANNEL SECTION AND USGS GAGING STATION

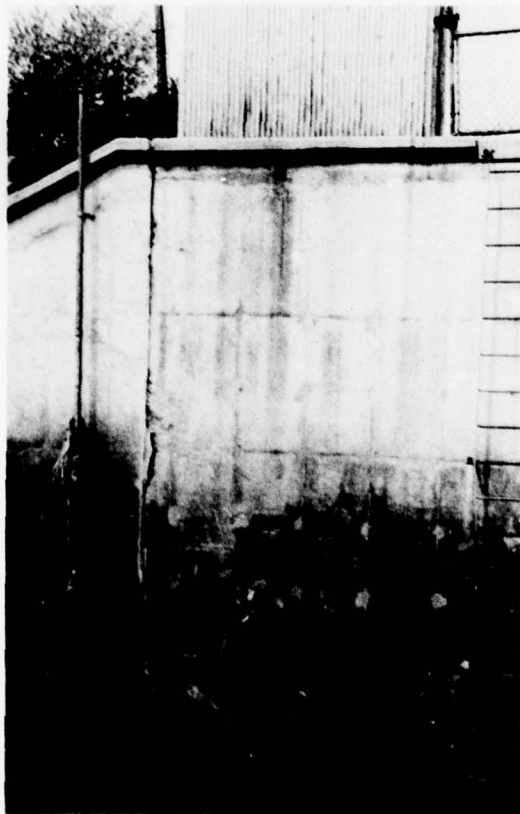
The concrete lined channel bottom was submerged at the time of inspection. The channel walls are relatively new and are generally in good condition except some minor spalling at construction joints.

LEFT CHANNEL WALL WITH  
SPALLING AT JOINT

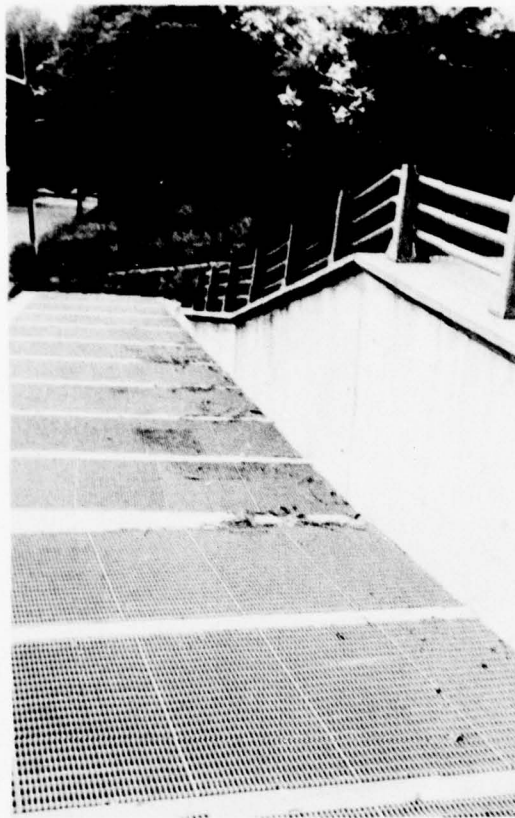
RETAINING WALL JOINT WITH SPALLING  
ALONG STORM WATER FLUME

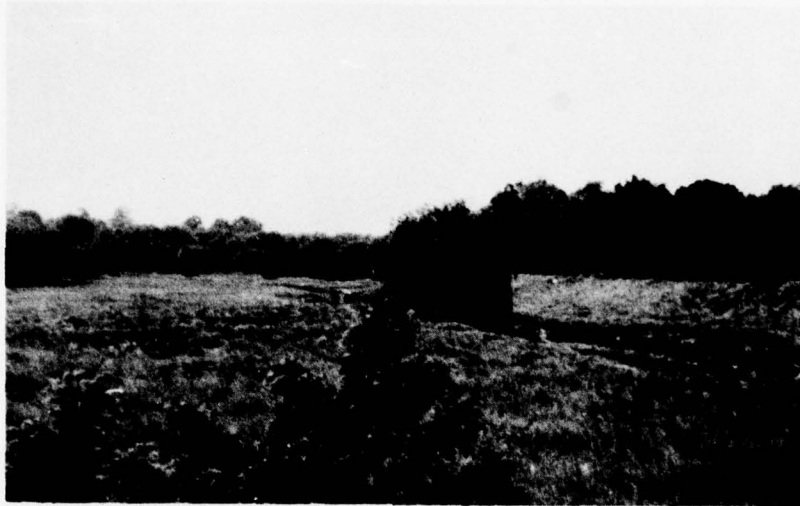
LOOKING UPSTREAM AT URSINO DETENTION BASIN WITH EAST LEVEE

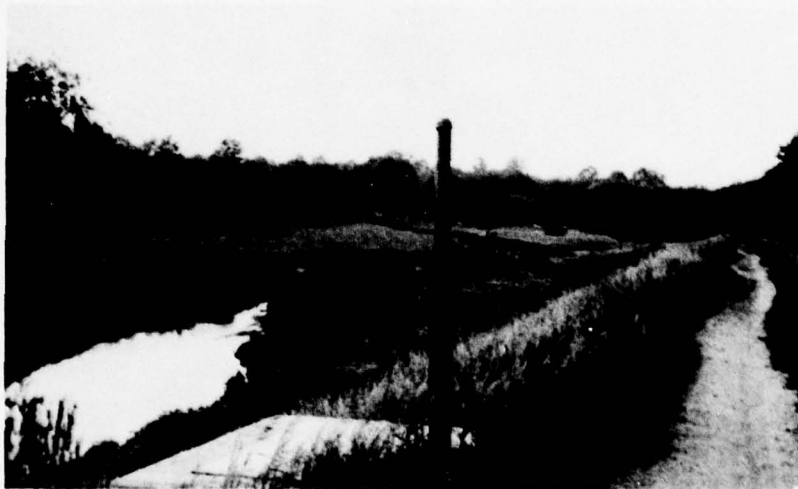
LOOKING UPSTREAM ALONG THE ELIZABETH RIVER  
WITH DRAINAGE STRUCTURE NO. 76 AND EAST LEVEE
